Subsurface analysis case study

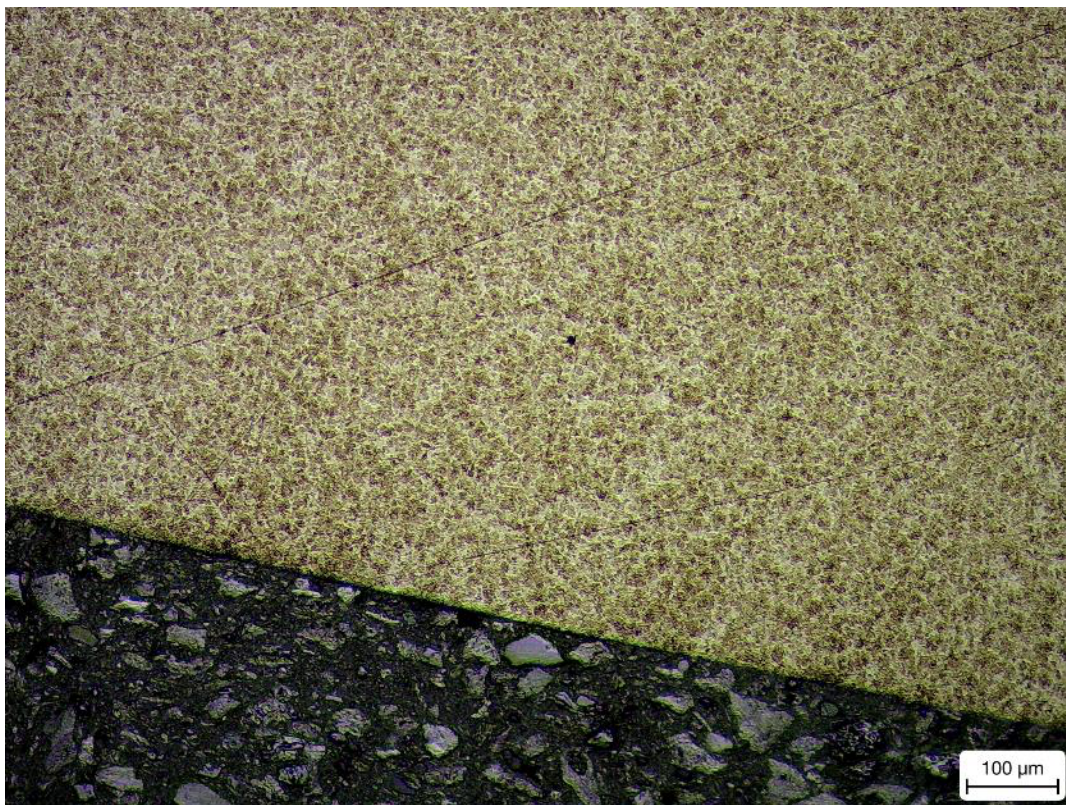
Figure 1 Examples of a subsurface image of the material below the surface of the bearing raceway.

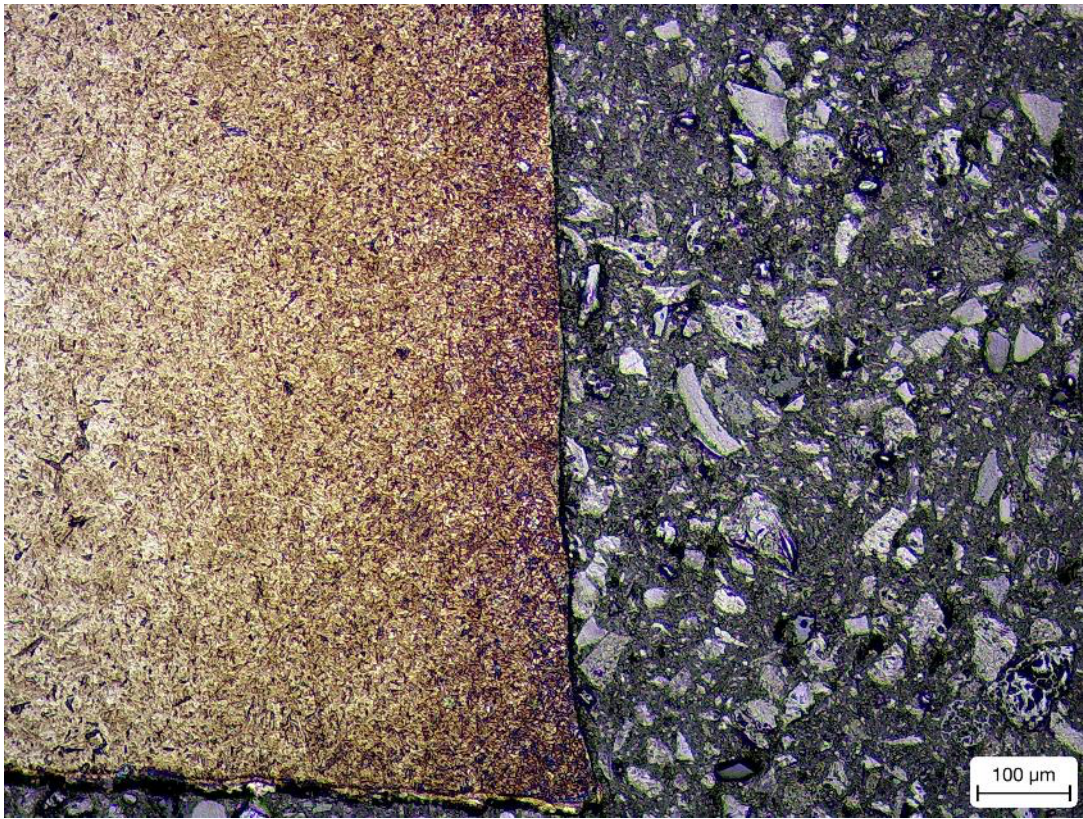
Figure 4 An example of a section of a gear tooth. Showing the wear of the gear dedendum.
